Manhole Inspection Summary

Manhole # S13S__029MH

Location Address: **3008 Wilkens Ave.**

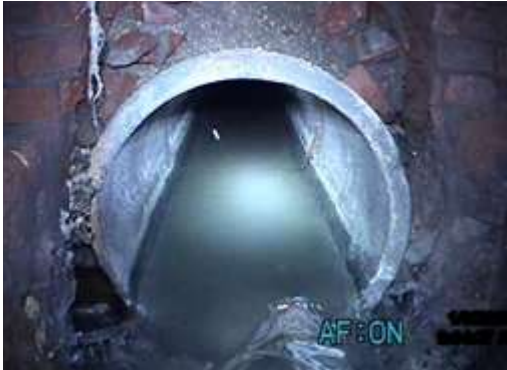
Defect 3

Condition: ☐ Sound ☒ **Cracked** ☐ Root Intrusion ☒ **Loose Brick** ☒ **Deteriorated**

Loose Bricks and Deterioration in Barrel

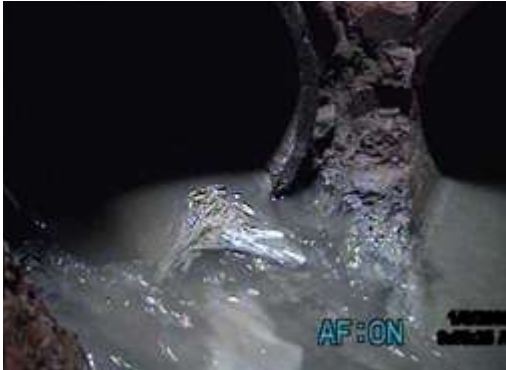
Defect 5

debris in channel

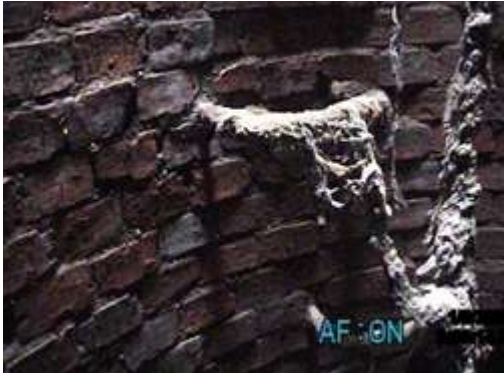
Defect 4

☒ **Evidence Of Surcharge** Depth: **3.5** (ft.) ☐ Active Surcharge Present

surcharge on rungs

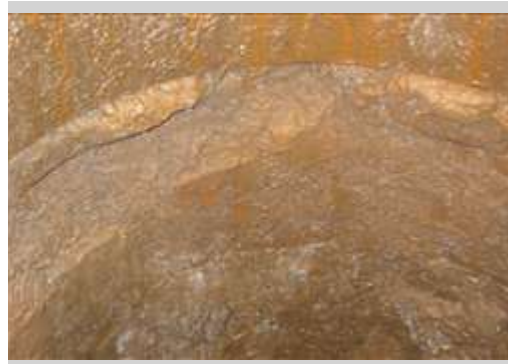
Defect 2

Condition: ☐ Sound ☐ Cracked ☐ Root Intrusion ☐ Loose Brick ☒ **Deteriorated**

Infiltration: ☐ None ☒ **Joint** ☐ Cracks ☐ Mortar ☐ Roots ☒ **Wall**

Infiltration: ☐ None ☐ Joint ☐ Cracks ☐ Mortar ☐ Roots ☒ **Wall**

Deteriorated Chimney and Corbel,
Infiltration in CHimney and Corbel

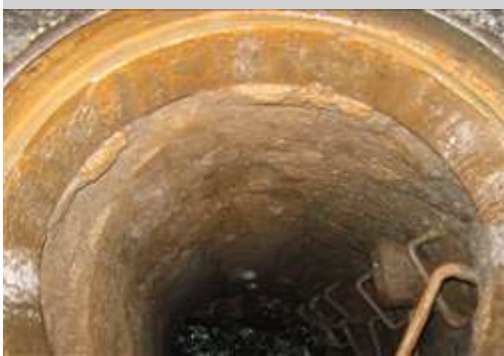
Defect 1

Condition: ☐ Sound ☐ Cracked ☒ **Leaks**

Frame Infiltration

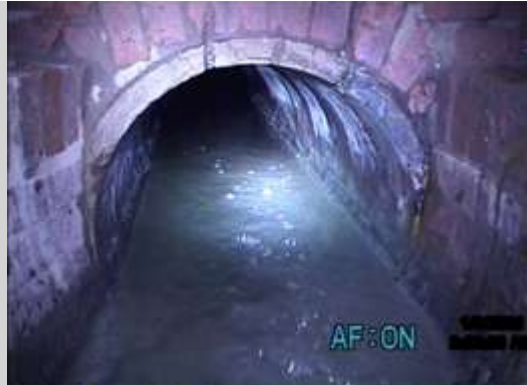
12 O'Clock Outflow

18 in. Circular Gravity Sewer
Pipe Out @ 12 O'Clock

Pipe Height: **19.2** (in.) Rod and Bar (Angled)
Pipe Material: **Clay** ☐ Pipe Lined
Invert Depth: **16.54** (ft.) Flow Characteristics: **Slow**
Deposits: ☒ None ☐ Mud ☐ Sludge ☐ Debris ☐ Grease
Silt Depth: **0** (in.) Deposits Extent:
Infiltration: **None** Pipe Seal Cond: **Sound**

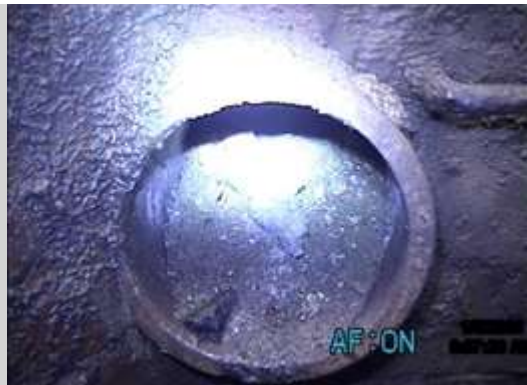
5 O'Clock Inflow

8 in. Circular Gravity Sewer
Pipe In @ 5 O'Clock

Pipe Height: **8.4** (in.) Rod and Bar (Angled)
Pipe Material: **Clay** ☐ Pipe Lined
Invert Depth: **4.30** (ft.) Flow Characteristics: **None**
Deposits: ☒ None ☐ Mud ☐ Sludge ☐ Debris ☐ Grease
Silt Depth: **0** (in.) Deposits Extent:
Infiltration: **None** Pipe Seal Cond: **Sound**

Connects To: **Stub connection / abandoned**

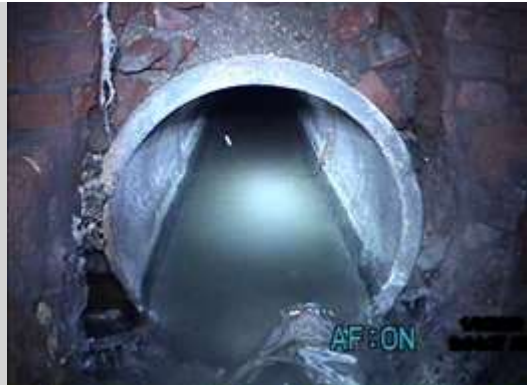
6 O'Clock Inflow

18 in. Circular Gravity Sewer
Pipe In @ 5 O'Clock

Pipe Height: **18** (in.) Rod and Bar (Angled)
Pipe Material: **Clay** ☐ Pipe Lined
Invert Depth: **16.20** (ft.) Flow Characteristics: **Slow**
Deposits: ☒ None ☐ Mud ☐ Sludge ☐ Debris ☐ Grease
Silt Depth: **0** (in.) Deposits Extent:
Infiltration: **None** Pipe Seal Cond: **Sound**

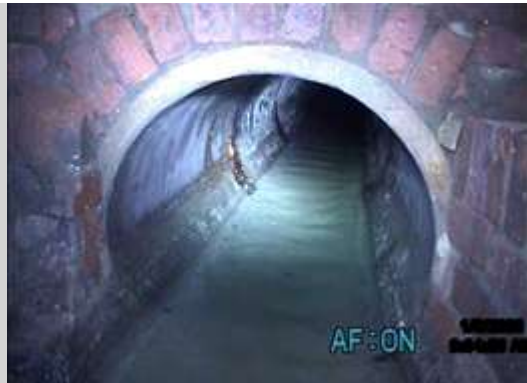
7 O'Clock Inflow

18 in. Circular Gravity Sewer
Pipe In @ 7 O'Clock

Pipe Height: **19.2** (in.) Rod and Bar (Angled)
Pipe Material: **Clay** ☐ Pipe Lined
Invert Depth: **16.43** (ft.) Flow Characteristics: **Slow**
Deposits: ☒ None ☐ Mud ☐ Sludge ☐ Debris ☐ Grease
Silt Depth: **0** (in.) Deposits Extent:
Infiltration: **None** Pipe Seal Cond: **Sound**
